# **NORTH KIGEZI & KINKIIZI DIOCESES WATER AND SANITATION PROGRAMME (NKKD WATSAN)**

**3rd Quarterly Report  
July - September, 2021**

During this 3<sup>rd</sup> Quarterly period July - September, 2021, NKKD WATSAN Programme mainly concentrated on the implementation of Ruheza GFS and Bwanga Hill Project.

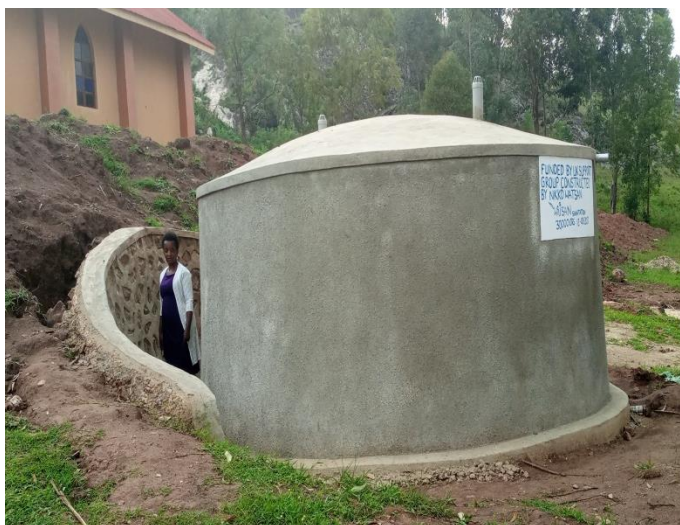
This tank is situated adjacent to the church building and is intended to serve resident staff and boys at Bwanga Secondary School. The purpose for this location is that the church is located uphill above the school staff quarters which enables water from the tank to move down to the school by gravity, and the church has a massive roof which helps to serve this tank with enough rain water.

After the construction, water connection was carried out using 25mm pipe line, covering a distance of 266 metres from the tank to the school. Then, three (3) tap stands were constructed, one to serve the Head teacher's residence; another, the staff quarters, and another, the boys' toilets and bathing shelter area.

**A 30m<sup>3</sup> Rain Water Harvesting Tank constructed at Bwanga Church by NKKD WATSAN to be used by student boys and resident staff at Bwanga SSS**

- (i) Site clearance
- (ii) Excavation and level to firm ground in boulder soils up to the depth of 1.5 metres and deposited the excavated soils from the site.
- (iii) Hardcore filling in foundation thickness not exceeding 200mm compacted and bounded.
- (iv) Plumbing works (pipes and fittings assembly)
- (v) Providing reinforcement iron bars 12mm for floor at a spacing of 125cc.
- (vi) Casting reinforced concrete cement in ratio (1:2:4) for floor thickness of 210mm
- (vii) Placing of 2 rolls of RBC mesh, providing high yield iron bars 10mm and chicken mesh.
- (viii) Reinforced motor masonry works in ratio (1:3) sand – cement plaster total thickness is 50mm.
- (ix) Cement punning in pure cement thickness not exceeding 3mm
- (x) Casted reinforced motor, sand cement in ratio (1:3) for slab.
- (xi) Placing of 600 x 600mm concrete man hole cover including locking arrangement.

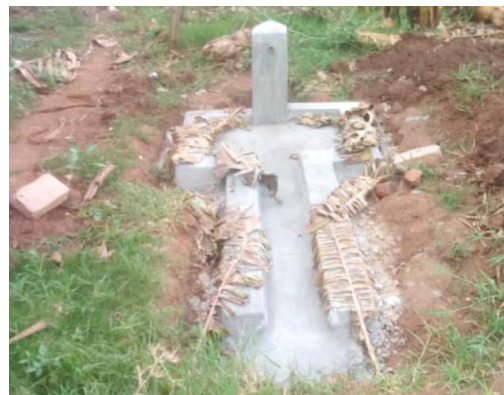
One of the constructed tap stands, Bwanga Hill Project.

- (i) Site clearance
- (ii) Excavation for foundation in ordinary soil
- (iii) Hardcore filling
- (iv) Plain concrete mix (1:2:4)
- (v) Concrete masonry works in (1:3) for drain
- (vi) Plastering pillar, drain and floor in two layers of 12mm (1:3) sand – cement plaster. Total thickness is 25mm
- (vii) Cement punning in pure cement. Thickness not exceeding 3mm.
- (viii) Excavating in ordinary soil for soak pit.
- (ix) Hardcore filling in soak pit
- (x) Placing heavy duty polythene paper sheet on hardcore to protect the pipe from surface water.
- (xi) Back filling ordinary soils, cleaning and shaping the area.
- (xii) Construction of live fence to prevent animals from entering inside tap area.

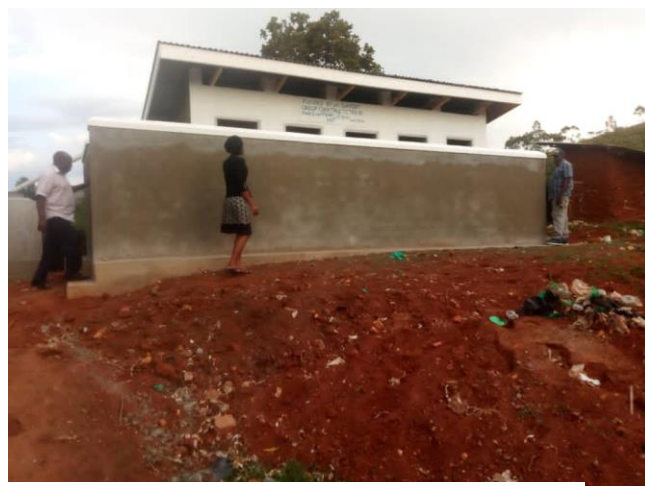
**No. 1.** This was constructed at Bwanga school in addition to another existing pit latrine to serve 295boys.

A lined five stance pit latrine with a urinal for boys newly constructed by NKKD WATSAN at Bwanga SSS

- (i) Pit excavation of this size: 22ft (length) x 8 ft(width) and 13ft (depth).
- (ii) Pit lining: brick masonry works in ratio (1:3)
- (iii) Ring beam construction in the pit at 8ft high which involved:
  - Placing high yield twisted iron bars nominal size 12mm
  - Casting plain concrete sand – cement (1:2:3)
- (iv) Slab construction which involved:
  - Placing of yields twisted iron bars nominal size 12mm
  - Casting plain concrete sand – cement (1:2:3)

- (v) Super structure construction. Each latrine has 5 stances, plus a urinal. As for the one at the church, it was divided into two with one side of 3 stances to be used by females and the second part of two stances and a urinal to be used by males.

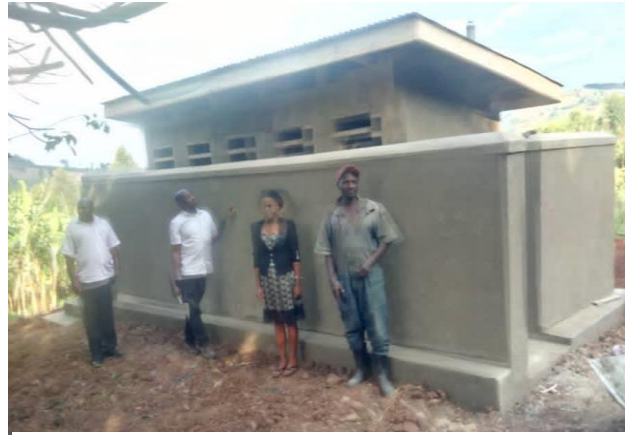
A lined five stance pit latrine with a urinal recently constructed NKKD WATSAN at Bwanga church

A slopping ramp in one of the entrances to enable the disabled access the facility, emptying access for future emptying, a curtain wall for privacy purposes and mirrors in some rooms.

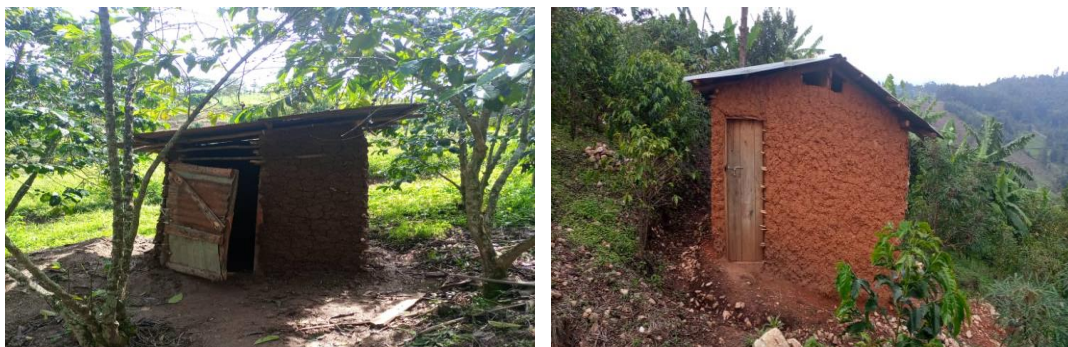
10 Bath shelters constructed; 8 Compost pits excavated; 15 Existing pit latrines improved and 2 new ones constructed, and 10 Dish drying racks constructed.

Some of the newly constructed pit latrines during project implementation

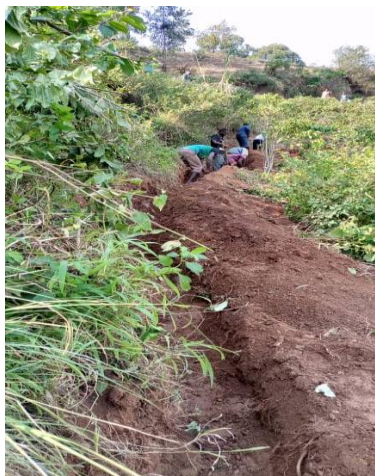
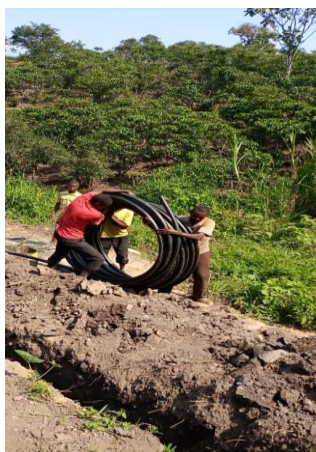
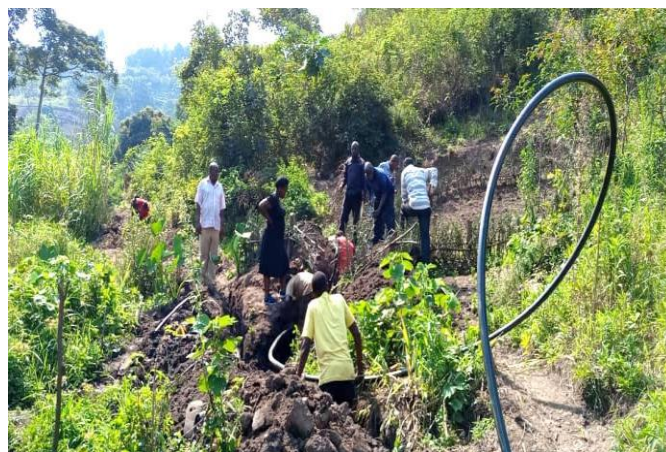
Trench excavation, pipe laying and backfilling of 1125m was already carried out by end of this quarter. This work was carried out manually by the Project beneficiaries with some relatively little payment by NKKD WATSAN merely to facilitate them for lunch.

Ongoing trench excavation and pipe laying for Ruheza GFS Implementation

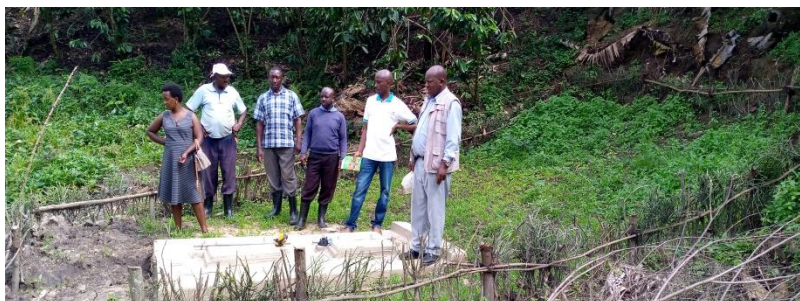
In order to have enough water in both the sedimentation tank and subsequently the reservoir tank, another water source intake was constructed. This makes the total

WATSAN staff with coordinator inspecting the water source intake No. 1 after its construction

- (iv) Hardcore filling in foundation
- (v) Placing of high yield iron bars 12mm
- (vi) Reinforced concrete sand – cement ratio (1:3) for floor thickness 100mm

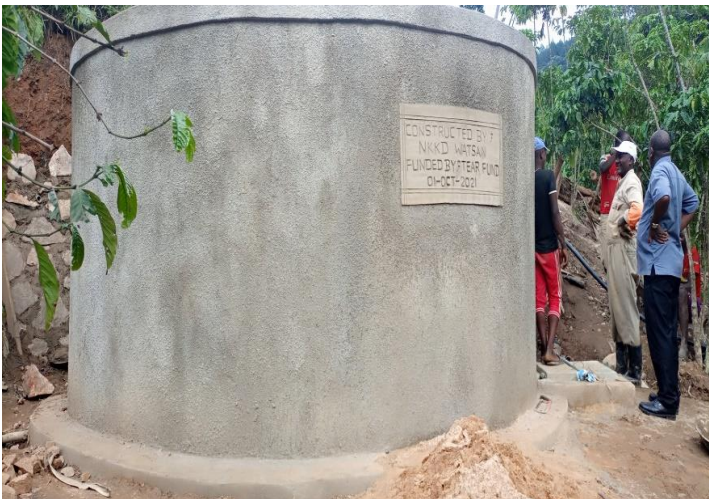
**A 20m<sup>3</sup> Reservoir tank, behind which a retaining wall is under construction**

sedimentation tank is reserved in this tank before it is distributed to tap stands. The construction of this tank was something hard to do especially because the site on which it was constructed was steep and it needed serious excavation and leveling of the site before its erection. To protect it against possible soil slides, a retaining wall was under construction for this purpose by end of this quarterly period.

- (i) Site clearance
- (ii) Excavation and level to firm the ground in mixed boulder soil up to depth of 3 metres.
- (iii) Excavation of strip footing
- (iv) Hardcore filling in foundation
- (v) Reinforced concrete sand – cement in ratio (1:3) for floor
- (vi) Plumbing works (pipes and fitting assembly)
- (vii) Stone masonry works in ratio (1:3) mortar mix
- (viii) Plastering inside the tank in three layers of 25mm (1:2) water proof cement plaster. The total thickness not exceeding 3mm.
- (ix) Plastering outside the tank in three layers of 25mm (1:2) sand – cement plaster. The total thickness is 75mm.
- (x) Reinforced concrete sand – cement standard mix for the slab
- (xi) Placing 600 x 600mm concrete man hole cover including locking arrangements.

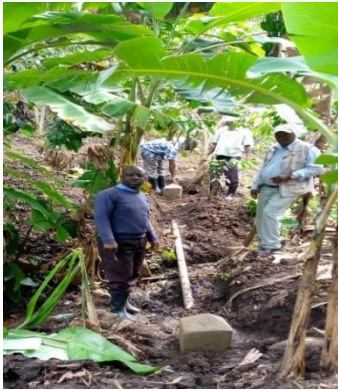
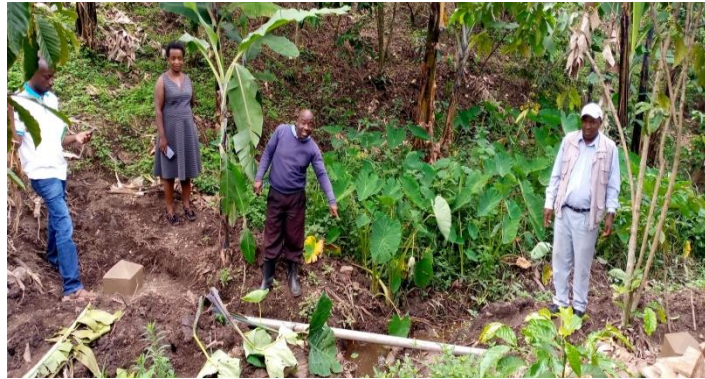
Three (3) stream crossing points have been made on the on the water pipe line to avoid pipe sagging and being eroded by the running stream water.

**Stream crossings on the water pipe line**

3No. stream crossing constructed using  $2\frac{1}{2}$ "G.I pipes as sleeves and two hail walls constructed to support the pipe from being washed away by the stream water.

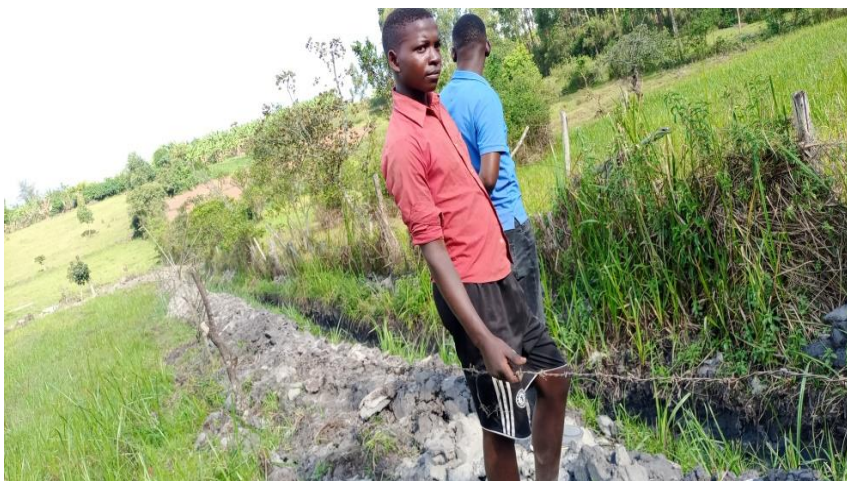
**Excavation of the drainage channel for Kiteme Spring**

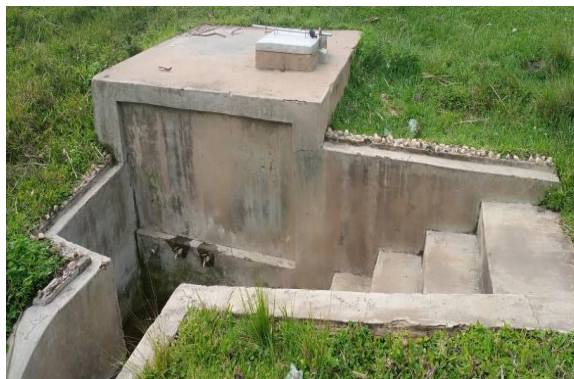
This spring is found in Rukungiri Municipality. It was also visited and some repairs made on it. Its tank had no cover putting at risk little children who could easily get drowned in it, or contamination of Water in the tank. So, a new cover was made and put on the tank. Two fetching taps of the tank had also broken and were now replaced. There was also general cleaning around the spring to improve the drainage and sanitation of the surrounding.

**Kinyasano Low yield spring repaired**

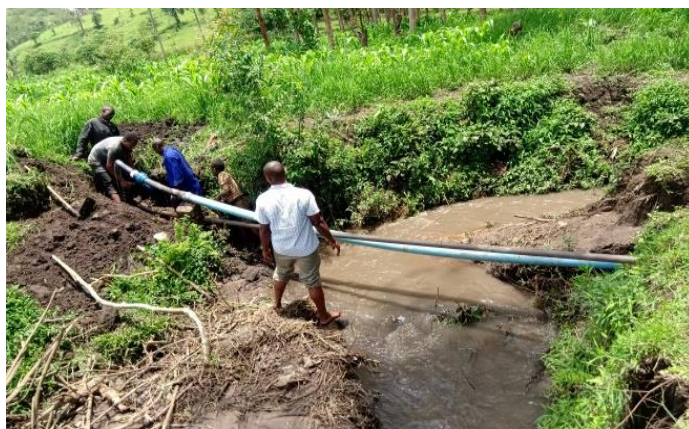
On a rather unfortunate note, due to heavy rains a 90mm main pipe at a stream crossing was washed away and required emergency attention. Luckily it was repaired in time by Watsan in collaboration with the Operation and Maintenance Committee. However this specific point had been identified as would be prone do disaster and therefore will require further attention that may include construction of new stream

**Repair of pipes on Nyambizi GFS**

crossing pillars and replacement of the GI pipe that has rusted. There are also other areas like at Kiruruma Bridge where pipes are hanging and will need technical intervention because they have been bursting and sometimes maliciously damaged by people who have sometimes cut them. The release valves at the reservoir tanks are not functional and therefore will need

replacements. There are also several points where the GI connections have rusted and are either leaking or will break anytime.

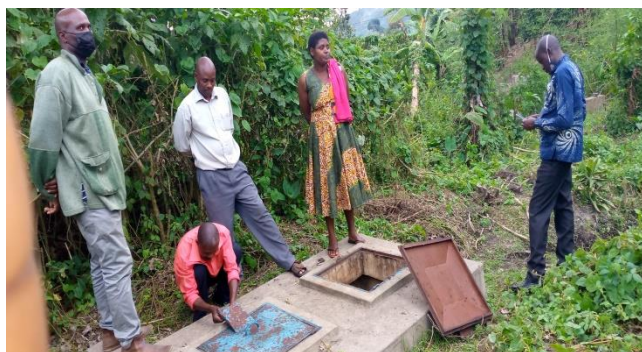
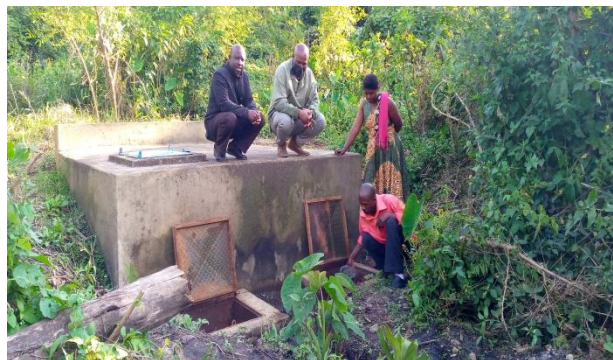
### **Inspection of water intakes at Kiringa GFS Source by members of O&M Committee and Kinkiizi Link Person.**

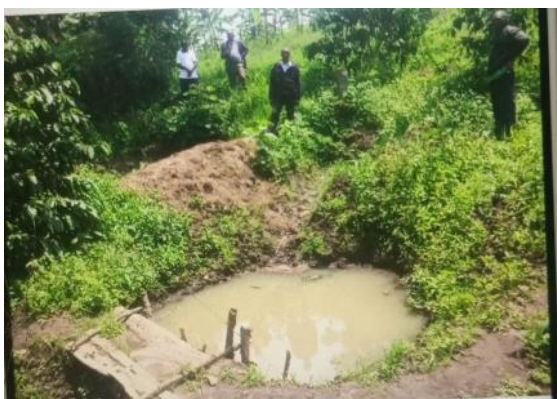
- (iii) **Water situation:** People within this community do not have a spring or any other system where they can access clean and safe water for domestic use. They depend on the running streams or pools of water.

Water pond where Kyabugashe community draws water for domestic use

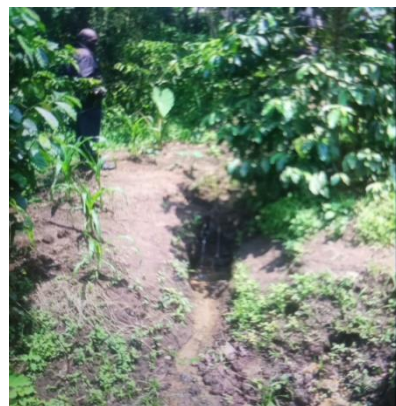
Fortunately during this baseline survey, a viable source was identified and it is advisable funds available to include a reservoir tank during spring construction.

Identified source for developing into a low yield spring
